National Construction Safety Team Investigation

The Station Nightclub Fire

NCST Advisory Committee
June 22-23, 2004

William Grosshandler

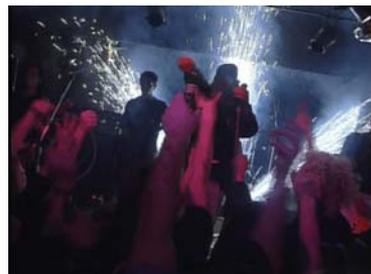
First flames, upper wall, left of stage.

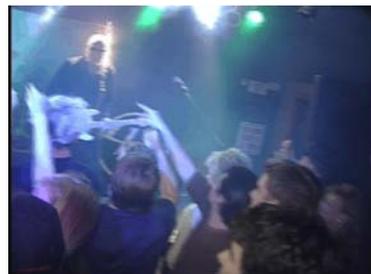
Flames on upper wall, right of stage.

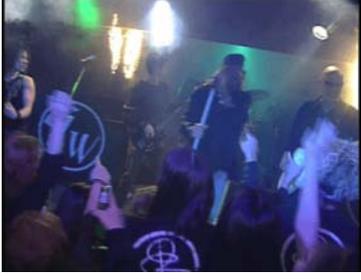
Band members first notice flames.

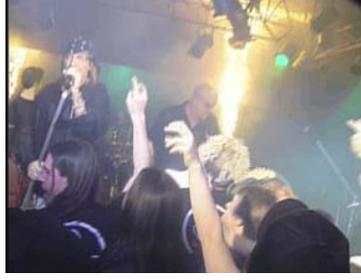
Flames reach ceiling, right of stage.

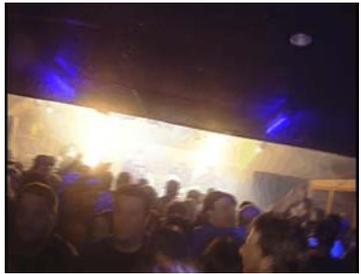
Flames touching ceiling, both sides.

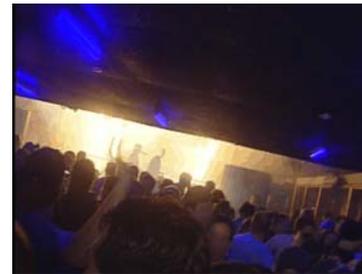
Flames extend fully above stage.

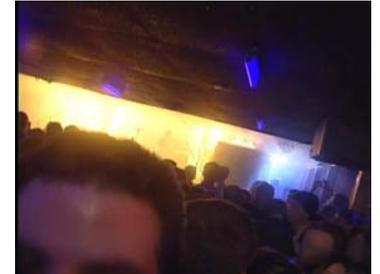
Alarm sounds; strobes begin to flash.

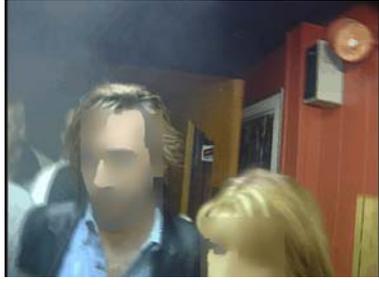
Smoke in exit lobby.

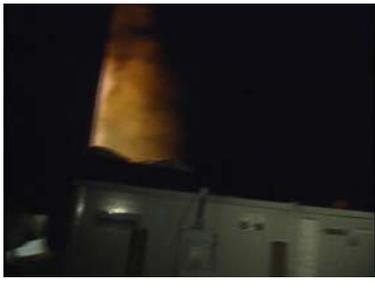
Smoke from stage exit, flames inside

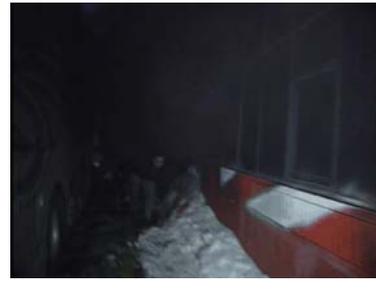
Smoke out of poolroom windows.

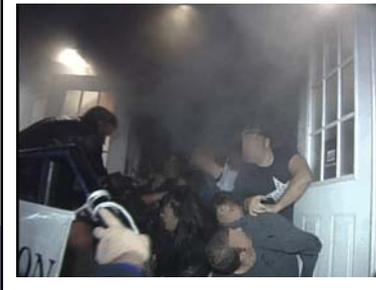
Occupants jammed in doorway.

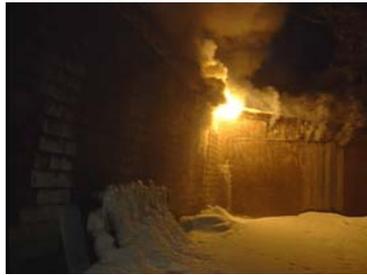
Flames near eave at rear of building.

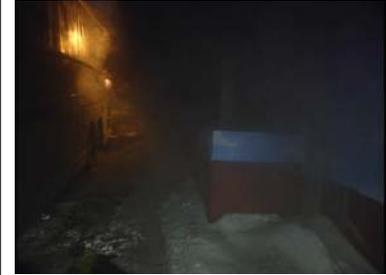
Flames out front of building.

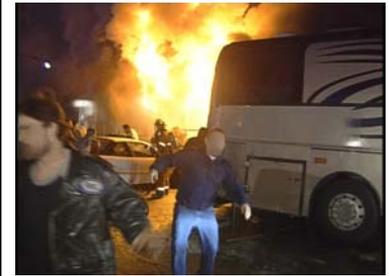
Flames extend from front windows.
